MTL TR 92-39

FAILURE ANALYSIS OF THE MAIN ROTOR RETENTION NUT FROM THE AH-64 HELICOPTER

MILTON LEVY, PAUL BUCKLEY, JOHN BEATTY,
RICHARD BROWN, ROBERT HUIE
U.S. ARMY MATERIALS TECHNOLOGY LABORATORY
METALS RESEARCH BRANCH

June 1992

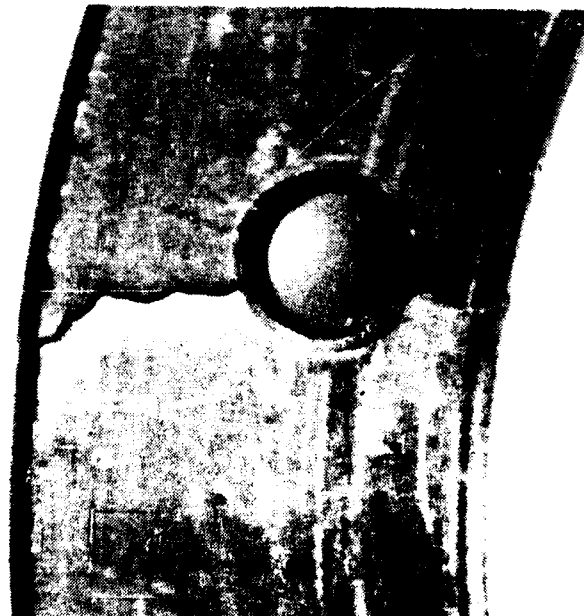
In the fall of 1989, upon inspection, one nut was found cracked, as shown in Figure 2a and 2b, (nut 0223). Subsequently, a Safety of Flight message was issued and a fleetwide inspection was carried out. A total of 10 nuts were reported as cracked, of which eight were confirmed. Two of these 10 nuts were found to be defect free upon re-examination in the laboratory. All the cracked nuts belonged to a *discrepant batch* heat 6644-A, Serial Nos. 0212 through 0226. These nuts were supplied to McDonnell-Douglas Helicopter Co. (MDHC) by FENN Manufacturing. The discrepant batch was forged by Teledyne Vasco. The drawing calls for a ring rolled microstructure. However, Teledyne Vasco reports indicated that ring rolling was not performed. The forged nuts were machined by McMellon Bros. Inc., and vacuum cadmium plated by Vacuum Deposited Coatings, Inc. per HP4-22. During the manufacture of the discrepant batch, hardness measurements (required for flight critical parts) were inadvertently omitted. Since this discovery was made after the cadmium plating operation, these nuts were sent to Westfield Electroplating for stripping of the cadmium by an ammonium-nitrate process. The cadmium stripping process renders the nuts prone to corrosion. The bare nuts were supposed to be protected with a corrosion prevention compound until they were replated. However, this operation was inadvertently left out for a few nuts, and verbal reports of isolated corrosion have been noted during the hardness measurements.

Figure 2. (a) Top view of main rotor retention nut 0223 showing crack transversing the thickness of the nut at a bolt hole. Note corrosion and wear evidence by the discolored regions.

Figure 2. (b) Bottom view of main rotor retention nut 0223 showing crack transversing the thickness of the nut at a bolt hole. Note corrosion and wear evidence by the discolored regions.

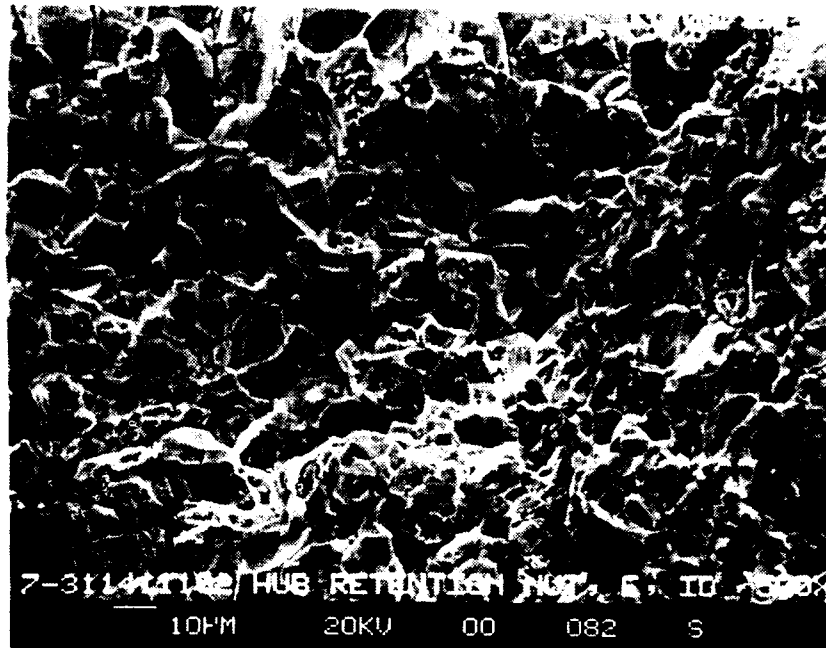
One of the cracked nuts (5TH-0223) was examined by MDHC and preliminary findings indicated the cause of failure to be hydrogen-assisted cracking as shown in Figure 3. The source of hydrogen was believed to be the result of a corrosion reaction in the field. MTL received the unused portion of this nut to perform a thorough failure analysis. During the course of investigation it became clear that additional factors were involved and efforts were directed towards determining if the problem was generic or isolated to a single batch. To that end, five additional nuts were received by MTL for examination and tests. Nuts 0223, 0257, and 0250 were from the discrepant batch. Nuts 0845, 0338, and 1202 were from other lots and showed no cracking.

Figure 3. McDonnell-Douglas SEM examination of fracture surface of nut 0223 indicating hydrogen-assisted cracking by the appearance of an intergranular crack path.

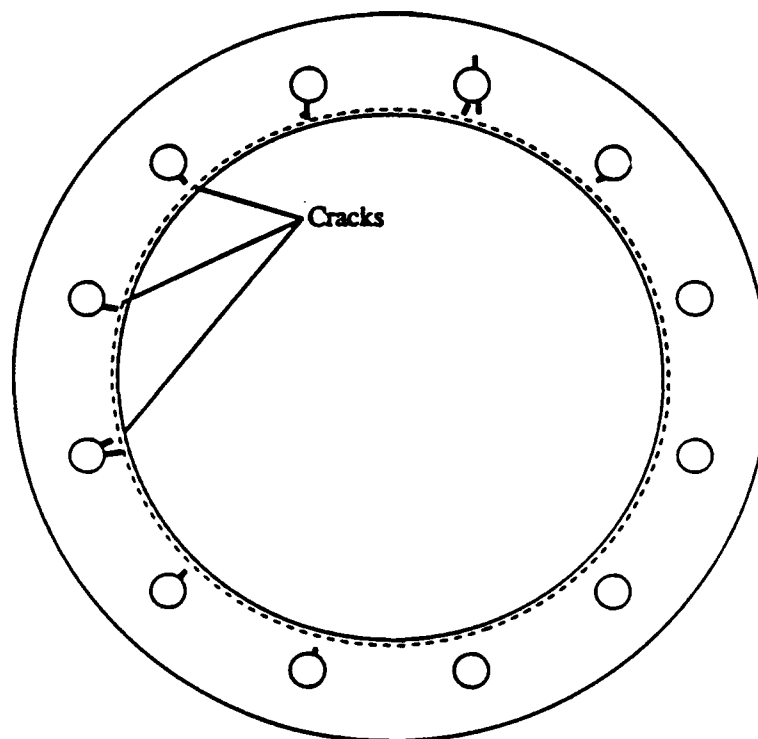
The retention nuts shipped to MTL were examined for irregularities and the presence of cracking. Nuts examined by MTL from heat 6644-A showed radial cracks emanating from one or more bolt holes. Figure 4 shows a schematic of nut 0257 and the locations of the radial cracks; additional typical cracks are shown in Figure 5. The radial direction of crack growth demonstrates that hoop stresses were the primary crack driving force. One nut examined, 0223, had experienced a complete fracture from the growth of one radial crack which, upon closer examination, showed the crack originated from the base of a thread root.

Figure 4. Schematic of main rotor hub retention nut 0257 with position of radial cracks emanating from bolt holes shown.

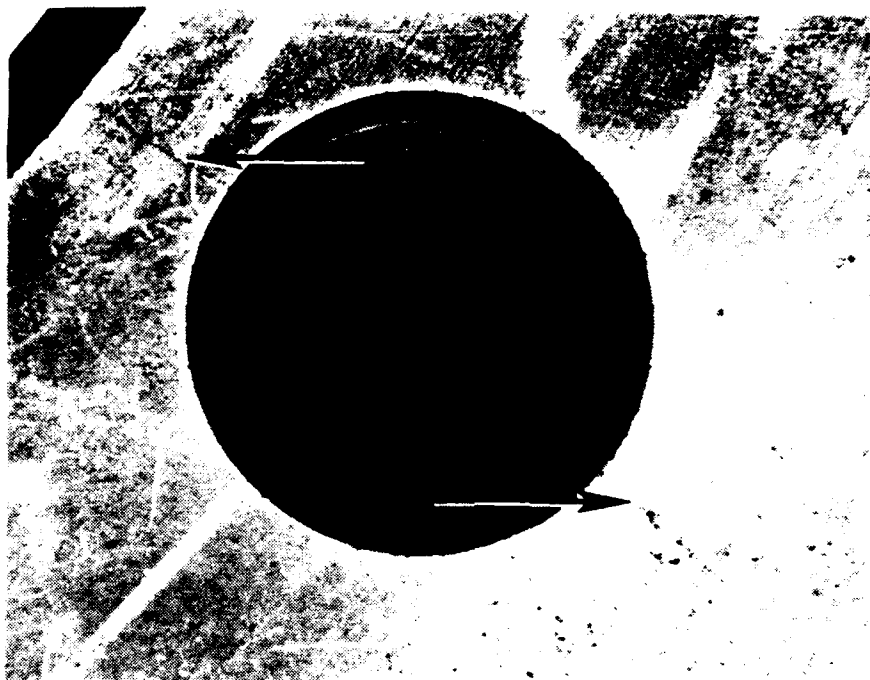
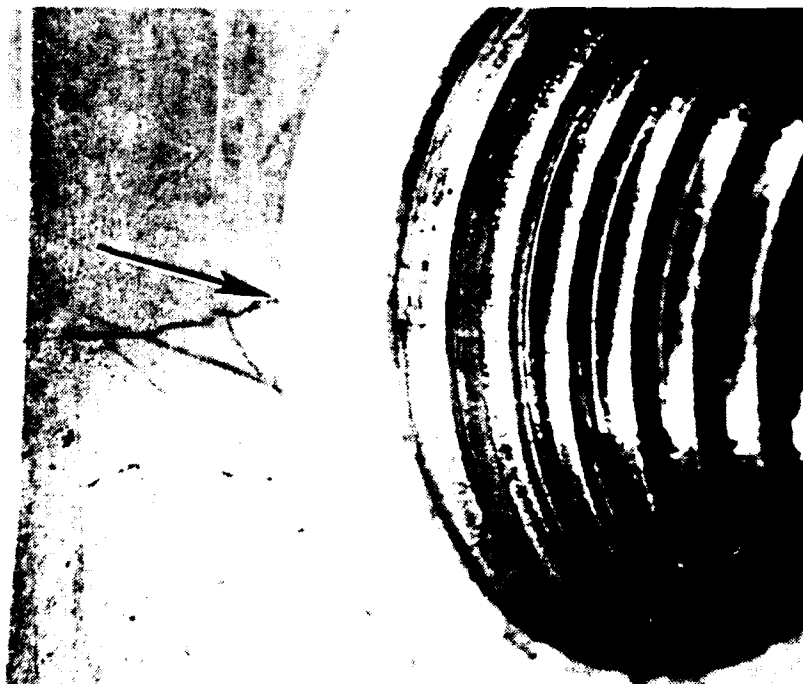
Figure 5. Optical micrographs of typical cracks emanating from bolt holes. Arrows denote location of cracks. (a) Mag. 7.5X., (b) Mag. 15X.
